# BUILDING-STRUCTURE INVENTORY FORM

1. BUILDING NAME(S): \_\_\_\_\_  
2. COUNTY: Monroe TOWN/CITY: Greece VILLAGE: ---  
3. STREET LOCATION: 1367 Ridge Road West (S.W. corner of Elmgard St.)  
4. OWNERSHIP: a. public ☐ b. private ☒  
5. PRESENT OWNER: Mary Giardino ADDRESS: (same) Rochester, NY 14615  
6. USE: Original: residence Present: office  
7. ACCESSIBILITY TO PUBLIC: Exterior visible from public road: Yes ☒ No ☐  
Interior accessible: Explain private office

Town of Greece Historic Sites Survey  
Monroe County, New York  
1367 Ridge Road West  
page 3

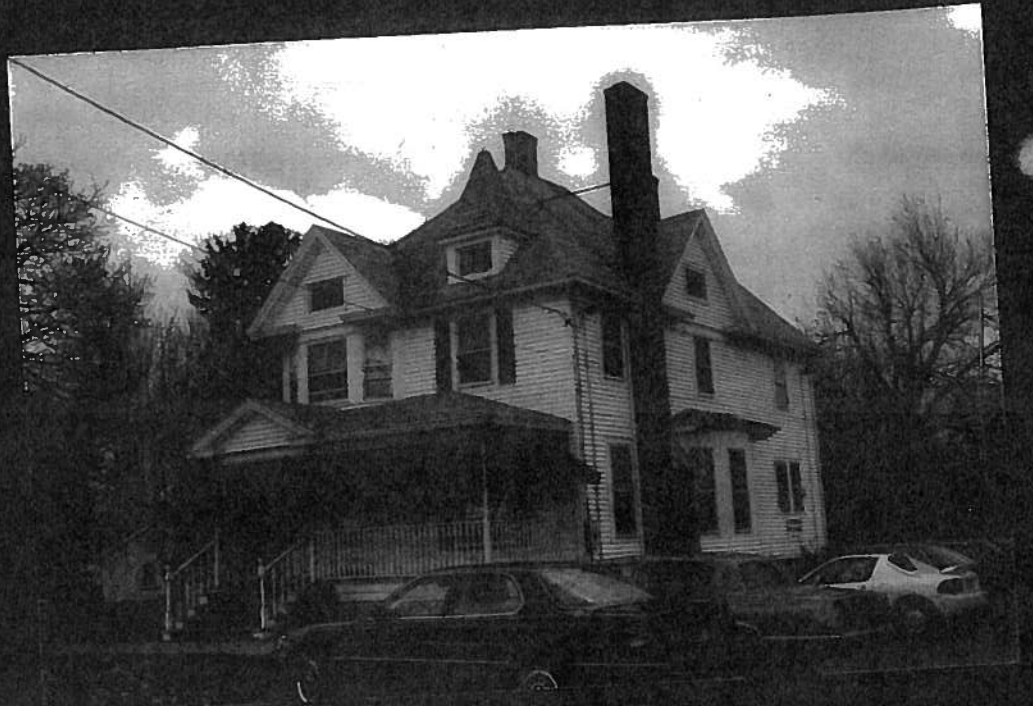
12. PHOTO:

"This house looks like it has original siding now covered with vinyl. Note the curious dormer with the little spire on it. It's a 'green.' " P. Malo.

The exterior is clad with contemporary vinyl siding. The original siding would have been wood (clapboards and/or shingles), which may survive intact underneath the vinyl. A tall brick chimney with iron tie rod is located on the west elevation; a small chimney is located on the ridgeline of the hipped roof and a third, small chimney is located on the west slope of the roof. Windows are principally 1/1, double-hung sash. However, there are four decorative windows in the attic level: two windows with diamond-pane transoms on the facade (north elevation) and two paired windows with small fixed, upper panes in the east and west gables. Cut-away windows bays are located on the facade and west elevations.

The gables feature steeply-pitched roofs and gable end returns. The front gable has decorative brackets underneath the gable end returns. The facade includes a small, decorative dormer with unusual, steeply-pitched roof.

The one-story, shed-roofed, front porch retains its original front gable, but its original wood posts and railing have been replaced with contemporary (c. 1980s-90s) wood posts and railing. These new wood posts and railings have turned detailing, but are not the same scale as the original posts and railings. The original porch posts and railing would have been a more substantial width to balance with the rest of the porch design. The contemporary replacements are much to "thin" in proportion.

At present the house is clad with contemporary vinyl siding and the original porch posts and railing have been replaced with contemporary, out-of-scale posts and railings. The architectural significance of this house would be enhanced with the removal of the vinyl siding, the repair/re-painting of the original wood siding, and the replacement of the porch posts and railings with appropriately scaled posts and railings.

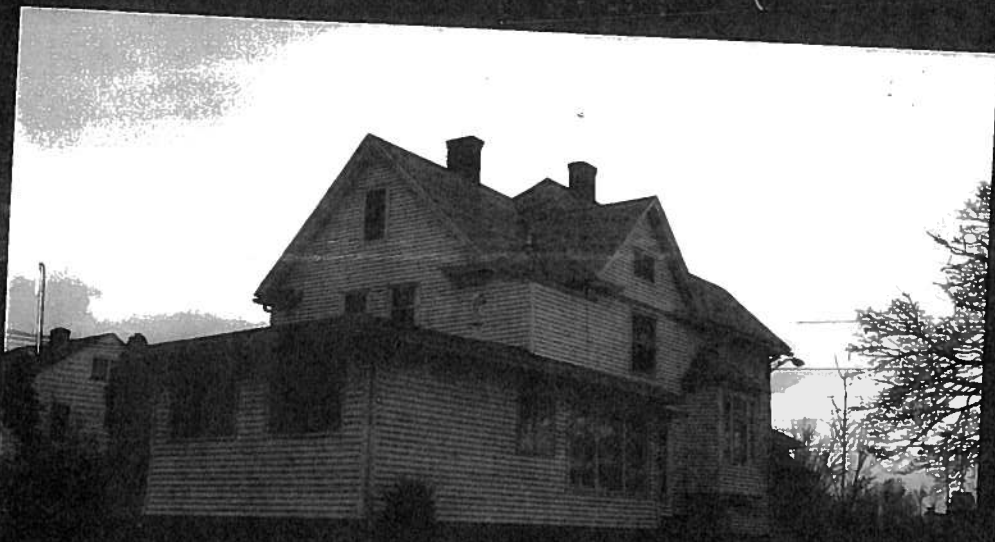
13. MAP:

17. This early-20th-century house is located on a 50-feet-wide by 151.57-feet-deep lot on the southwest corner of Ridge Road West and Elmgard Street. It is situated in the southeast quadrant of the town. The house faces north onto Ridge Road, a busy, four-lane highway. To the west and south (rear) of the house is a paved parking lot. The surrounding neighborhood along Ridge Road is mostly commercial. To the south of the house is an early/mid-20th-century residential neighborhood.
